## **Buwooya Alexander Borehole**

Completion Report

June 2024

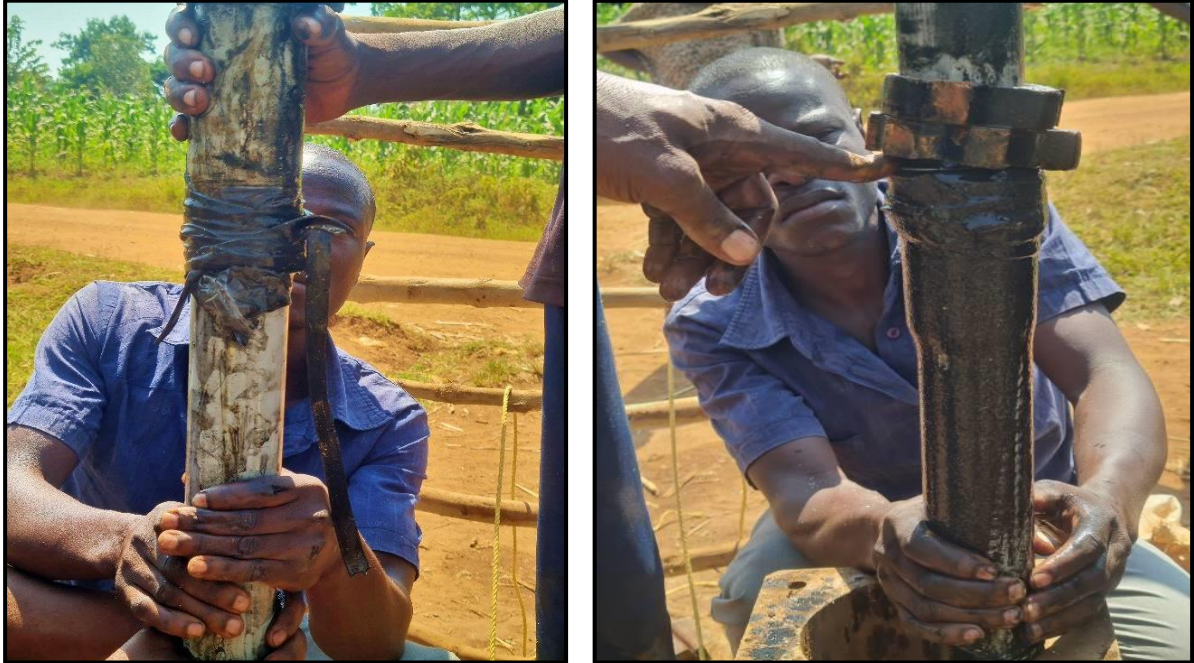
In the recent past, the government and many development partners had come to believe that the operation and maintenance of point water sources is not manageable because of the high frequency of breakdowns. The Busoga Trust team through a thorough study identified the major reason, and by far the most important, was the quality of parts installed. Most of the boreholes which needed serious rehabilitation had been installed with poor-quality pipes such as rust-prone galvanised iron and low-quality plastic pipes. Let's take the example of Buwooya Alexander which was installed with Uganda Mark 3 Modified (U3M) plastic pipes that kept cracking and breaking each time a repair needed to be done. In fact, the community resorted to tying strips of rubber around the pipes to stop the leakage, as shown in the photos below.

***The Buwooya Alexander community couldn't afford to replace the pipes outright so they had improvised by wrapping any cracked pipes with strips of rubber to stop the leakage of water.***

- The poor-quality Uganda Mark 3 Modified (U3M) pumping system was replaced with durable stainless-steel pipes, rods and cylinder.
- After rehabilitation, the community was introduced to a Water Service Provider (WSP) who will be responsible for routine maintenance of the water source under the Payment by Results (PBR) programme.
- The Water User Committee (WUC) was re-trained to oversee the day-to-day running of the hand pump.

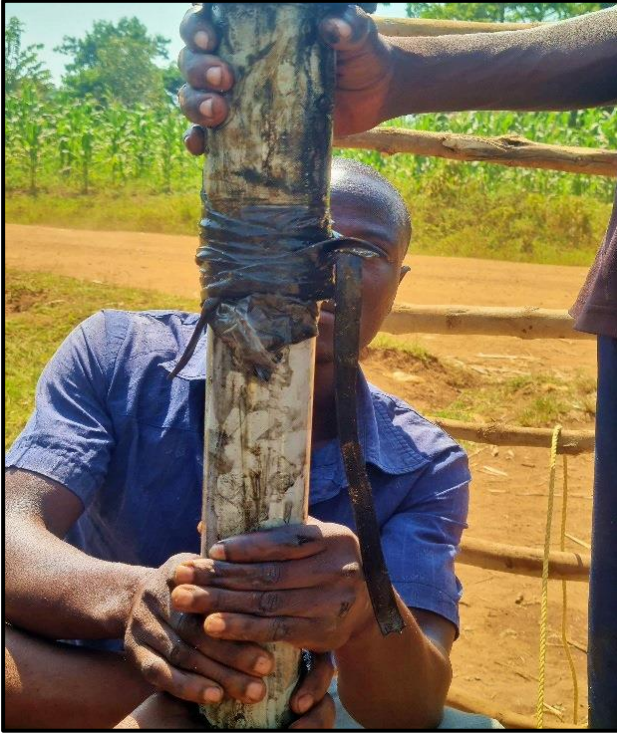
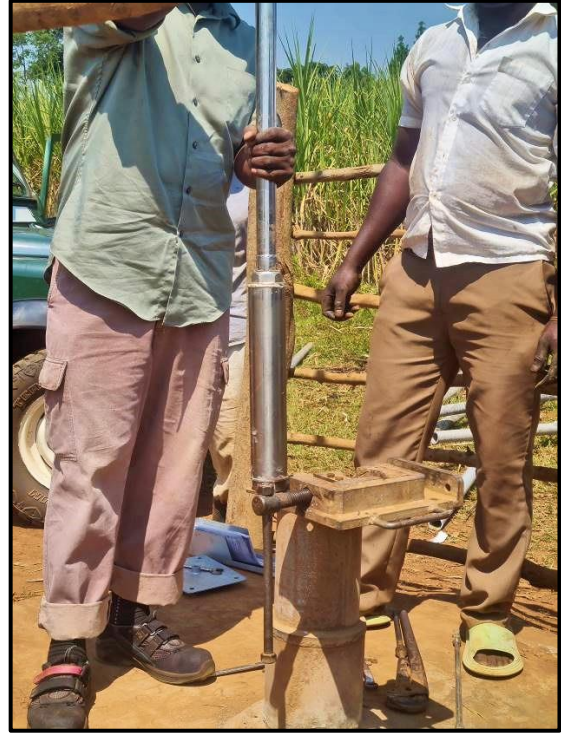
*The plastic pipes and cylinder were replaced with resilient stainless-steel material.*

The Buwooya Alexander borehole was completely overhauled, removing the broken plastic pipes and installing high-quality stainless-steel parts. This rehabilitation will ensure that the borehole continues to function and is easier for the community to maintain. On behalf of the Buwooya Alexander community, the Busoga Trust would love to pass a vote of thanks to our dear donors at The Rotary Club of Minehead and The Rotary Club of Yeovil for sharing the little you have with the needy in Uganda, may God bless the work of your hands.

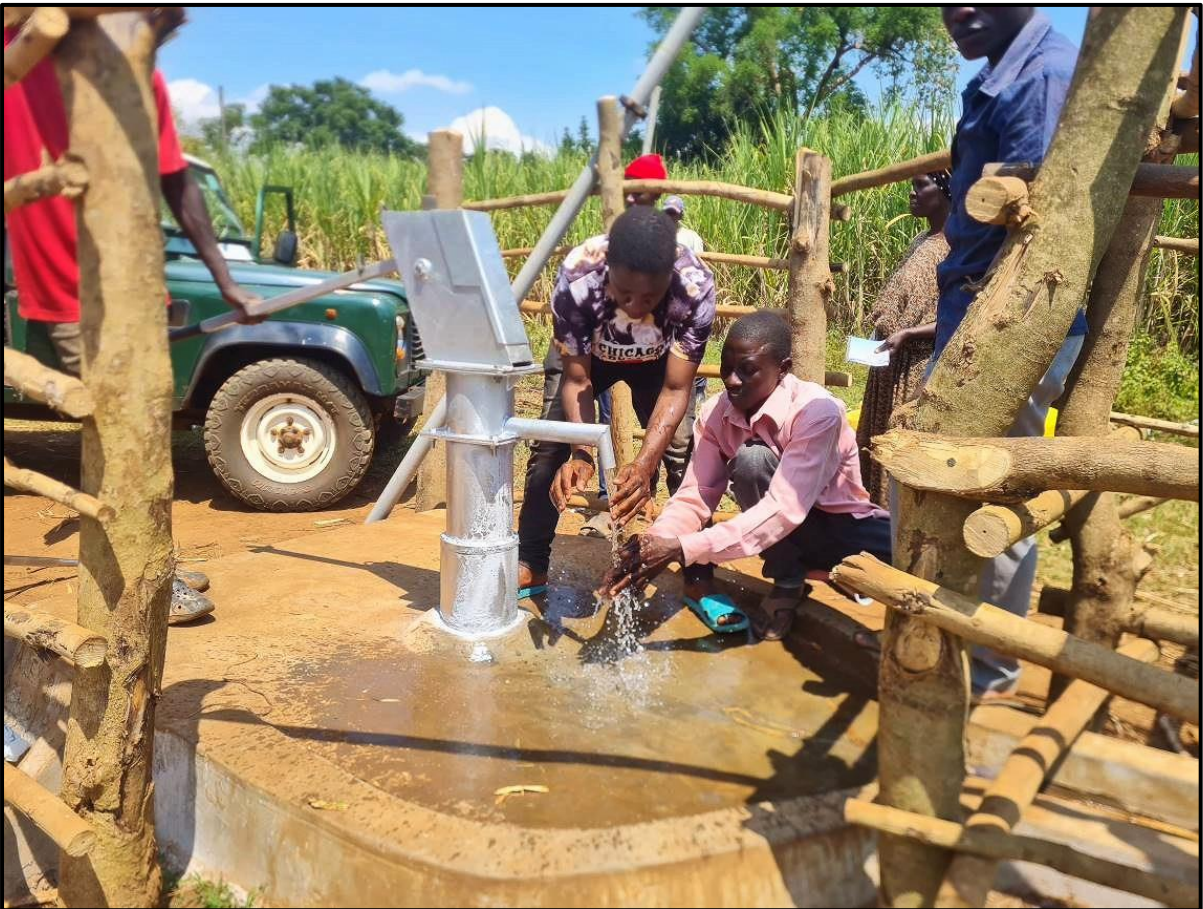
*Flowing water after the rehabilitation of the Buwooya Alexander borehole.*

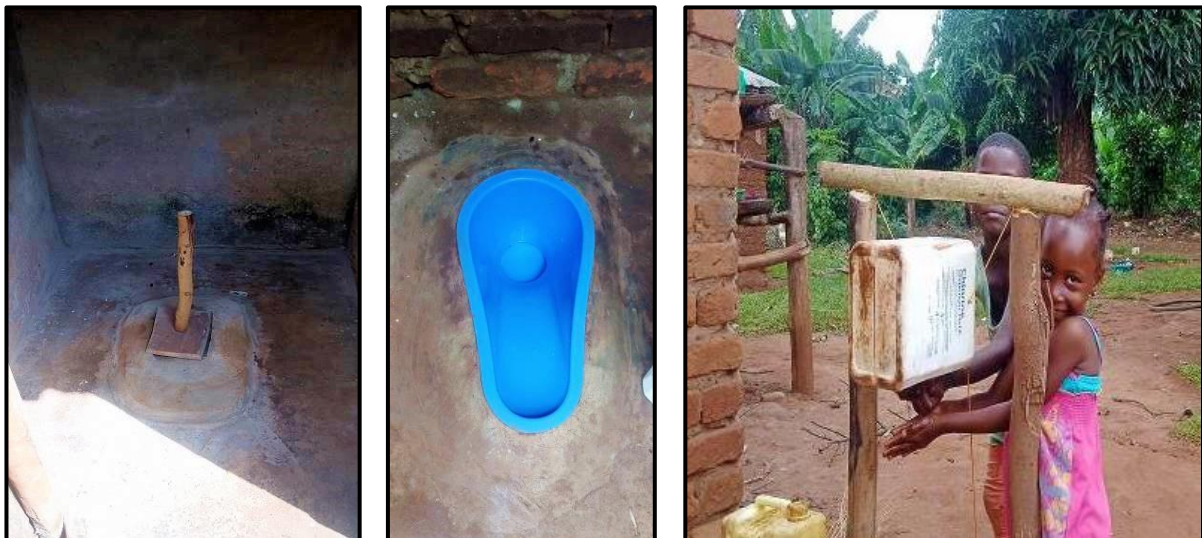
***A latrine that had a traditional pit cover was replaced with a plastic Sato Pan that automatically snaps shut after use, thus preventing flies and bad smells. Tippy-tap handwashing facilities were constructed beside each latrine.***

At the beginning of the intervention, a baseline survey was conducted to better understand the status of the village which later informed the strategy which was employed to trigger change. Back-and-forth follow-up visits were conducted to target individual households and make any necessary improvements. Community members were taught about the importance of handwashing and how to make simple tippy-tap handwashing facilities. The expected features of a good latrine were emphasised, and community members were introduced to an effective latrine add-on, the Sato Pan, that prevents flies from accessing food and drastically improves a basic latrine.

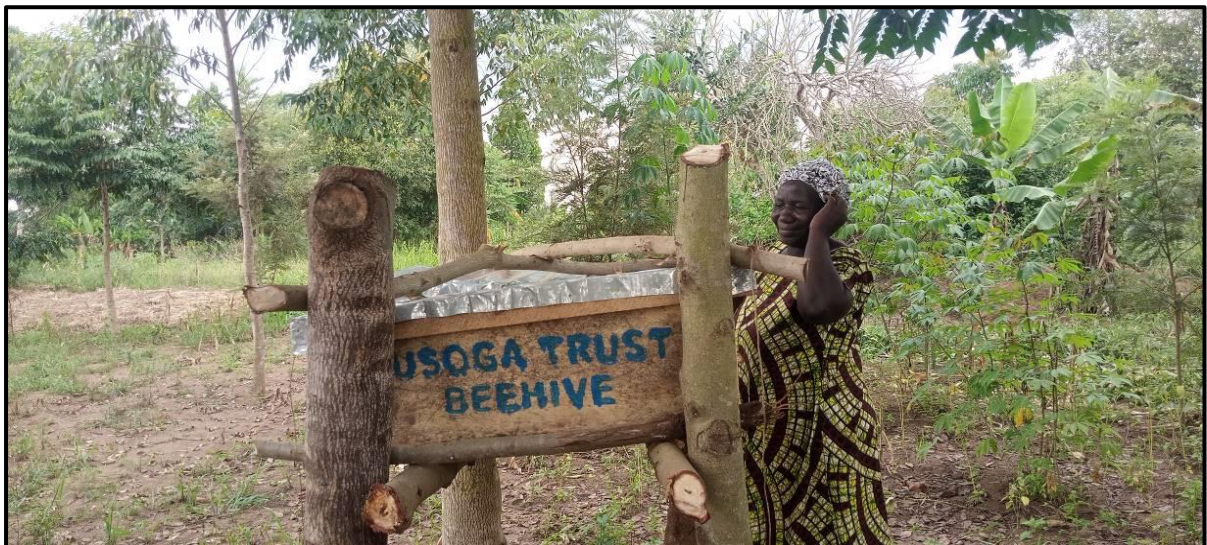
*An installed beehive delivered by the Busoga Trust.*
